DEPARTMENT OF TRANSPORTATION

[Docket No. FAA-2018-0454; Product Identifier 2017-NM-056-AD]

Airworthiness Directives; Airbus Airplanes

ACTION: Notice of proposed rulemaking (NPRM).

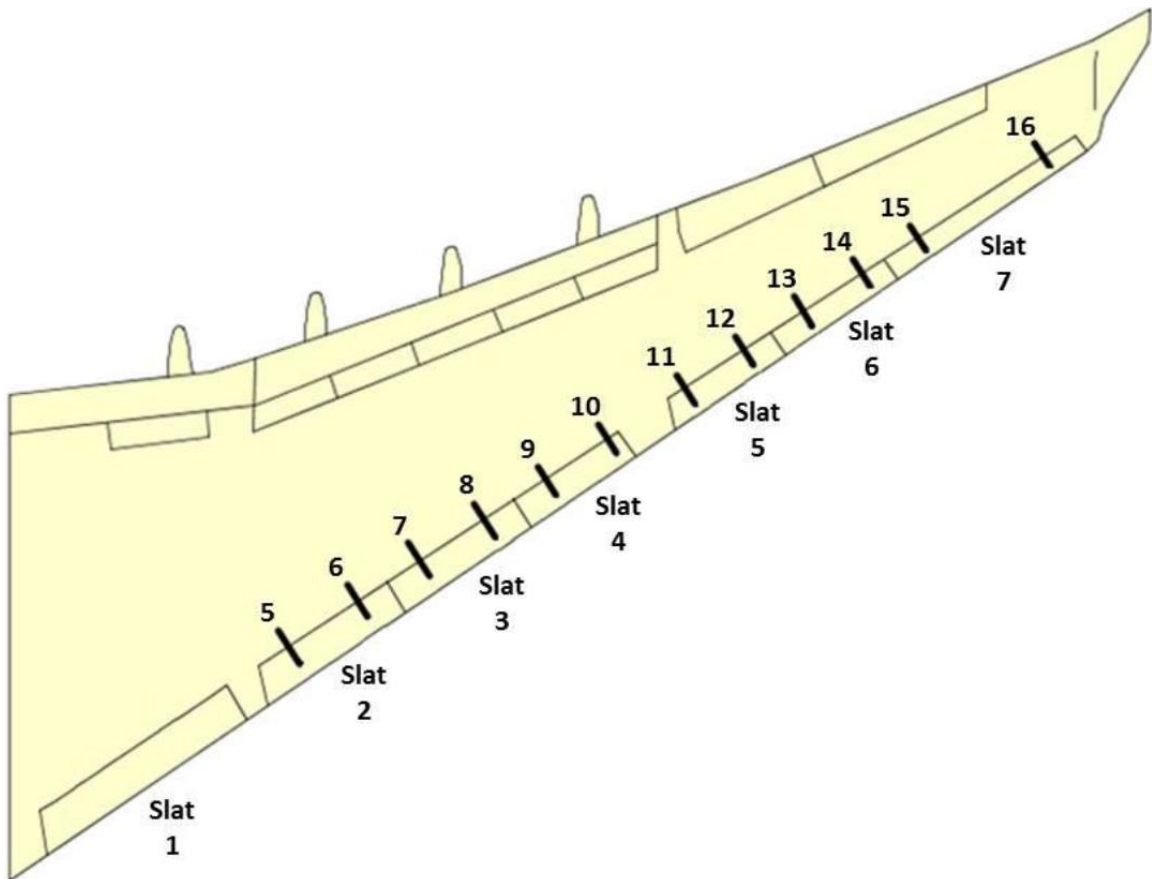
Figure 1 to paragraph (g) of this AD – *Positions of Affected Slat Tracks*

(1) For the purpose of this AD, “affected slat track” is defined as a pre-modification 45967 slat track, located at the wing positions as indicated in figure 1 to paragraph (g) of this AD, and having a part number specified in figure 2 to paragraph (g) of this AD. In case the part number identification (ID) plate is missing or cannot be read, the slat track can be identified by the ink marking. If the operator cannot determine the part number, then that airplane is in Group 1.
